## Atlantic Restoration set to complete phase II façade restoration at The Landing at One Chestnut

June 23, 2023 - Construction Design & Engineering

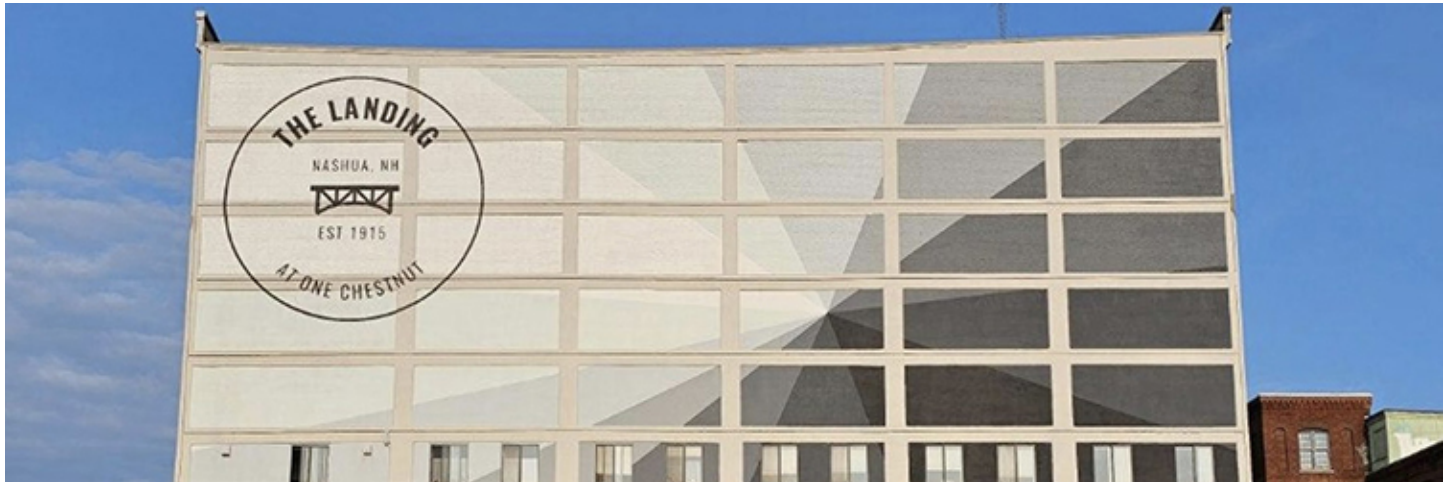
The Landing at One Chestnut after restoration

ARC installed a unique coating design after repairs were made on the east elevation. The “sunburst” designed by Ganek Architects was installed by priming the entire façade using Beograd’s Multigrip Primer II and using seven custom colors created using Neogard’s Neoflex elastomeric coating system.
