Atlantic Restoration set to complete phase II façade restoration at The Landing at One Chestnut

June 23, 2023 - Construction Design & Engineering

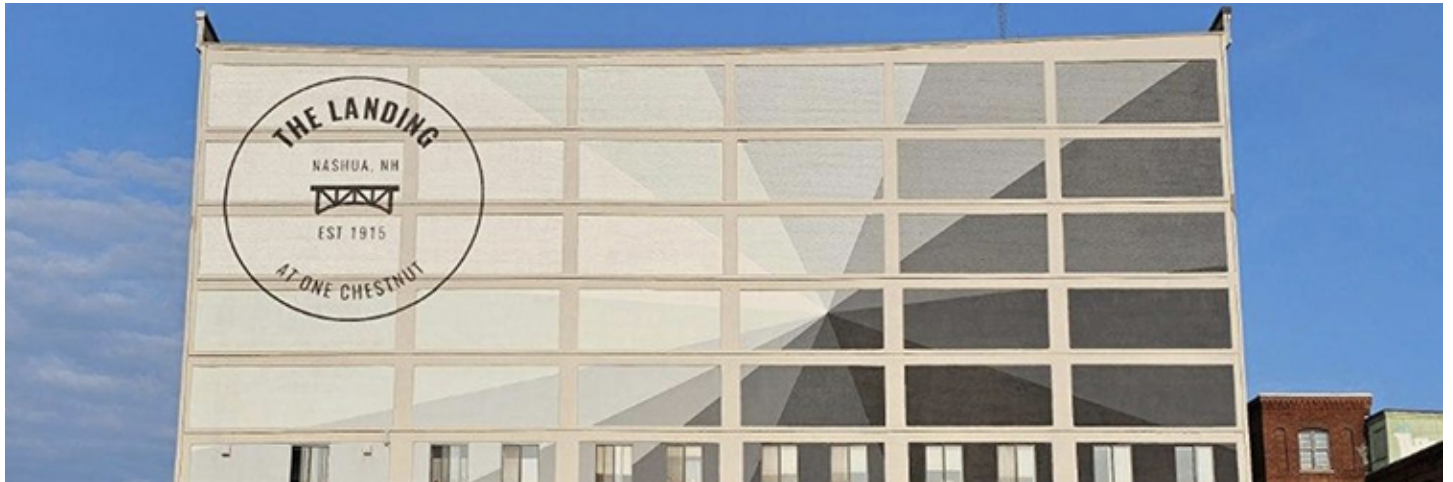
The Landing at One Chestnut after restoration

The multi-phase restoration project began in 2021 and consisted of a full façade restoration on the east elevation, partial repairs on the north elevation, and installation of an elastomeric coating along

the lower level of the full perimeter of the façade. The scope of work for phase 1 included extensive concrete repairs, joint sealant replacement, masonry repairs including, cutting, and pointing and brick replacement.

ARC installed a unique coating design after repairs were made on the east elevation. The “sunburst” designed by Ganek Architects was installed by priming the entire façade using Beograd’s Multigrip Primer II and using seven custom colors created using Neogard’s Neoflex elastomeric coating system.

Phase II of this project began in February 2023 and is set to be completed by this summer. This

work scope consists of extensive concrete repairs, concrete crack injections, replacement of window sealants and installation of a new elastomeric coating to complement the existing coating that was placed in phase 1 of the project.
